South Carolina

Annual State of the Beaches Report

2008

Ocean and Coastal
Resource Management

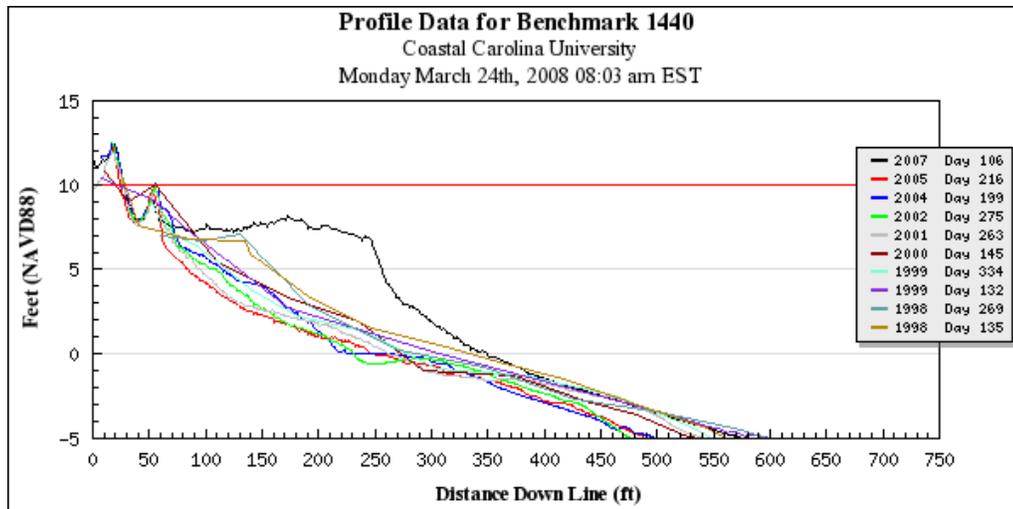
In North Forest Beach and Palmetto Dunes the long-term shoreline change rates become erosional. Beach profiles here showed sand deficits prior to renourishment, but unit-width volumes increased dramatically as a result of the 1997 and 2006 beach fill projects. Stations 1437 through 1448, located in North Forest Beach, showed substantial erosion of the renourishment berm between September 1998 and November 1999, but only minimal loss of renourishment sand since then. A steep profile still exists in the 2007 survey data, indicating the project is still equalizing to the wave climate.

Figure 3. Beach profiles for station 1440 in North Forest Beach on Hilton Head Island.

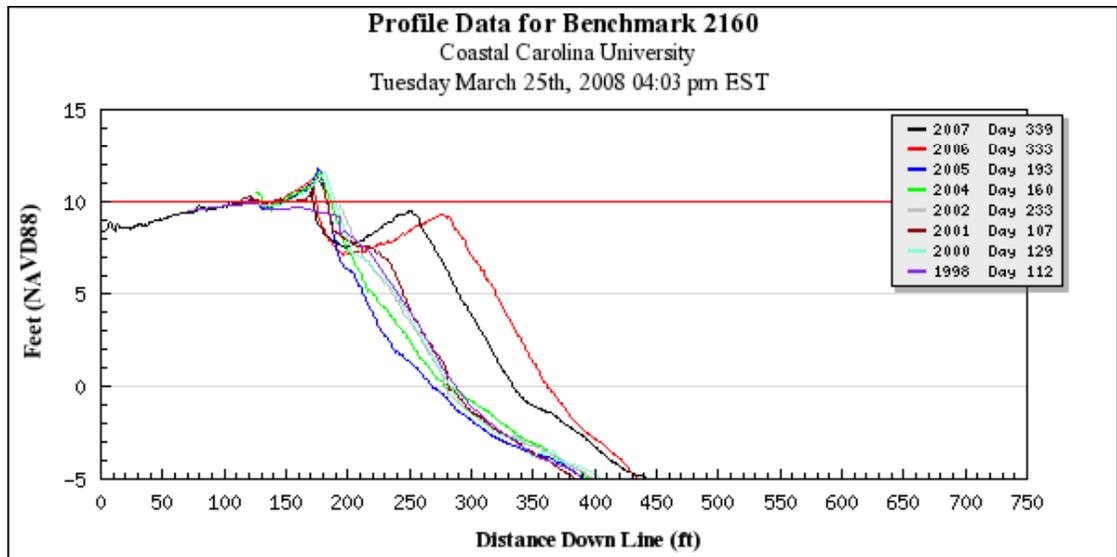
The oceanfront southern half of Edisto Beach, from stations 2145 to 2165, has the widest oceanfront beach on Edisto. Most stations here experienced only minor seasonal changes through July 2005. The 2006 renourishment to this section of Edisto added a 100-ft berm, which eroded 10 to 25 ft between 2006 and 2007.

Figure 8. Beach profiles for Station 2160 on Edisto Beach.

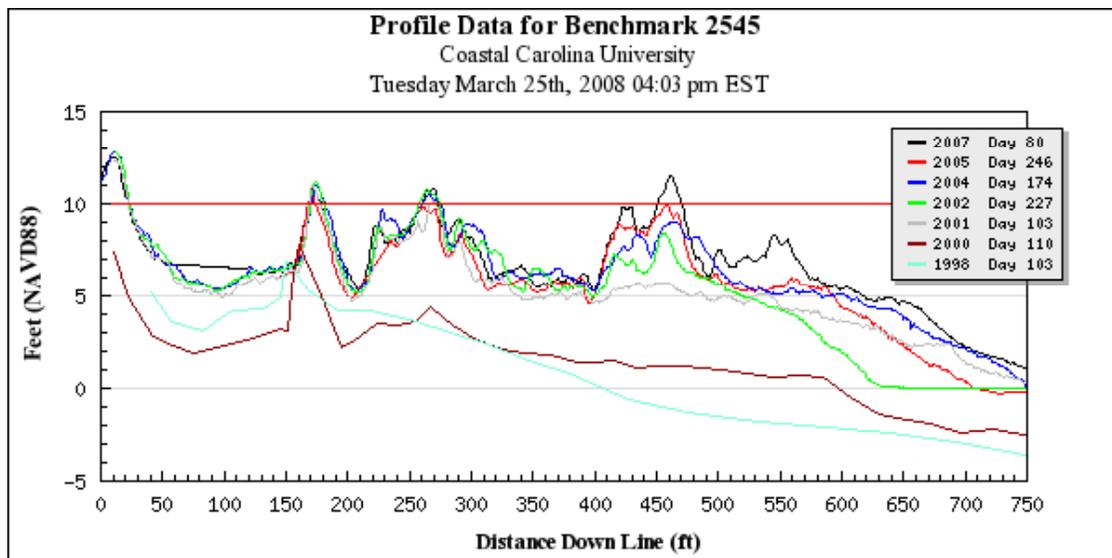
Figure 10. Beach profiles for station 2545 on Seabrook Island.

In the North Beach area, from station 2545 to 2575, the high-tide beach averages over 500 ft in width. This area is closer to Captain Sam's Inlet and its nearness to the inlet causes the shoreline to be more dynamic, experiencing episodes of moderate erosion or accretion from one year to the next. However, the substantial width of the dry-sand beach makes these changes of less concern than they might be elsewhere. In 2005 station 2545, near Cobia Court, showed a stable dune field and moderate changes on the intertidal beach. This trend continued into 2007, with the formation of an additional small dune 100 ft seaward of the 2005 dune. At station 2565 near Seascape Court the dune was stable but the beach seaward of the dune eroded back about 100 ft. Station 2570 off Oyster Catcher Court experienced some dune erosion and also lost about 75 ft of beach seaward of the dune from 2004 to 2005, while the region between 0 and 5 ft in elevation eroded on average 30 ft.

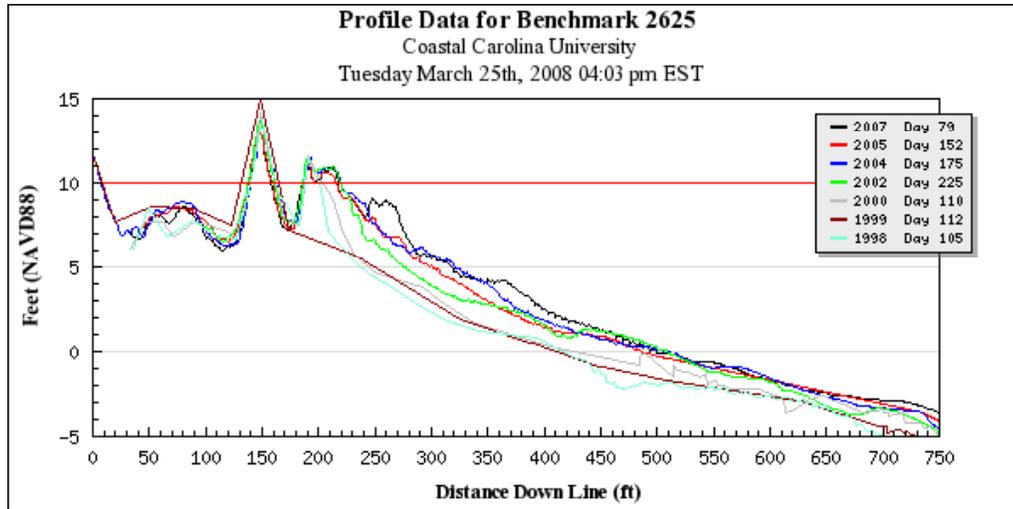
Eighteen beach monitoring stations on Kiawah Island were most recently surveyed in June 2004, May and June 2005, and March 2007. Stations 2615 through 2645 are located at the western end of Kiawah, where land use consists of undeveloped property, a beach park, single-family homes, and some multi-family structures. This is usually one of the most stable sections of Kiawah Island. For all stations here the primary dune was stable and the beach profile seaward of the dune showed either no change or minor accretion. Some of the 2007 profiles document the formation of a small dune twenty ft seaward of the 2005 shoreline.

Figure 12. Beach profiles for station 2625 on Kiawah Island.

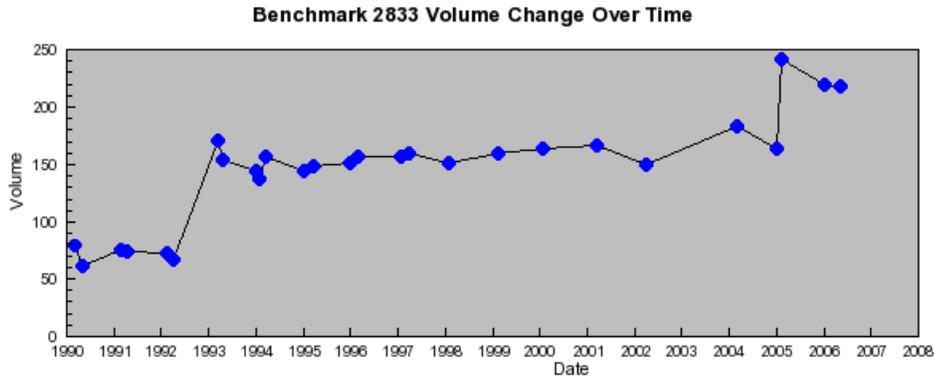
The next section of beach is the first eight blocks east of the Holiday Inn, from station 2833 up to 2843 at 8th St. East. This area has a moderate dune over or seaward of the line of rock revetments. Almost all profiles in this area were eroding during the current survey period, with a loss in the upper beach of over 75 ft in places between January 2006 and December 2007.

Figure 14. Change in volume of profile 2833 over time on Folly Beach. Notice the 1993 and 2005 renourishment.

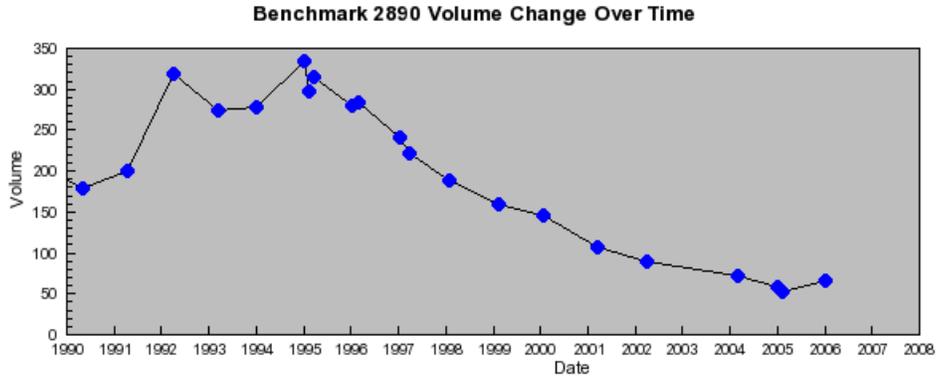
In the region from station 2873, just east of the Washout, to 2885, near the Sumter Drive beach access parking area, all stations experienced a general trend of accretion on the upper beach and intertidal beach. In most cases the dune was cut back by 20 to 25 ft. The last monitoring station, 2890 on the former Coast Guard base property, also showed considerable dune scarping and erosion on the upper and intertidal beach. The volume of sand present in the profile has steadily declined since the mid 1990's.

Figure 15. Change in beach profile volume through time at station 2890 on Folly Beach north of the Washout.

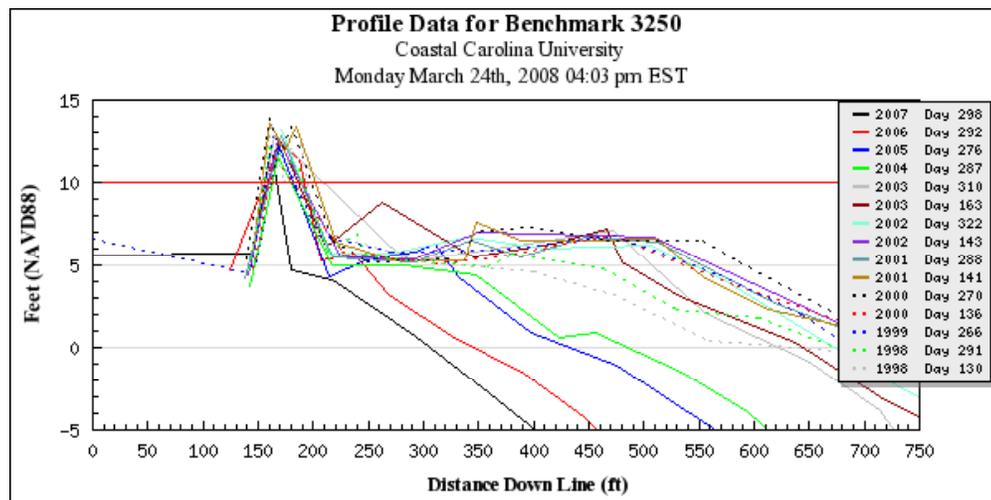
Figure 18. Profile data for station 3250 on Dewees Island.

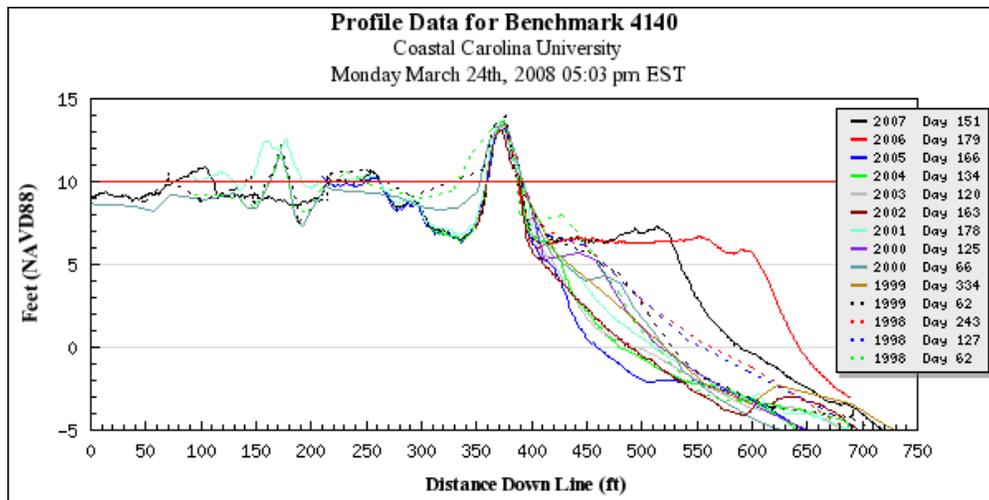
Figure 20. Beach profiles for station 4140 on DeBordieu Beach. Note the 2006 renourishment and landward migration through 2007.

previous year this station saw erosion between the +7 ft and -2 ft contours, as the beach cut back by up to 25 ft. The renourishment project added approximately 200' of beach to the profile with approximately 68 cubic yards of fill material per ft of beach. Between June 2006 and May 2007, 70 ft of beach has been lost and the profile steepened. A similar loss is noted at station 4150.

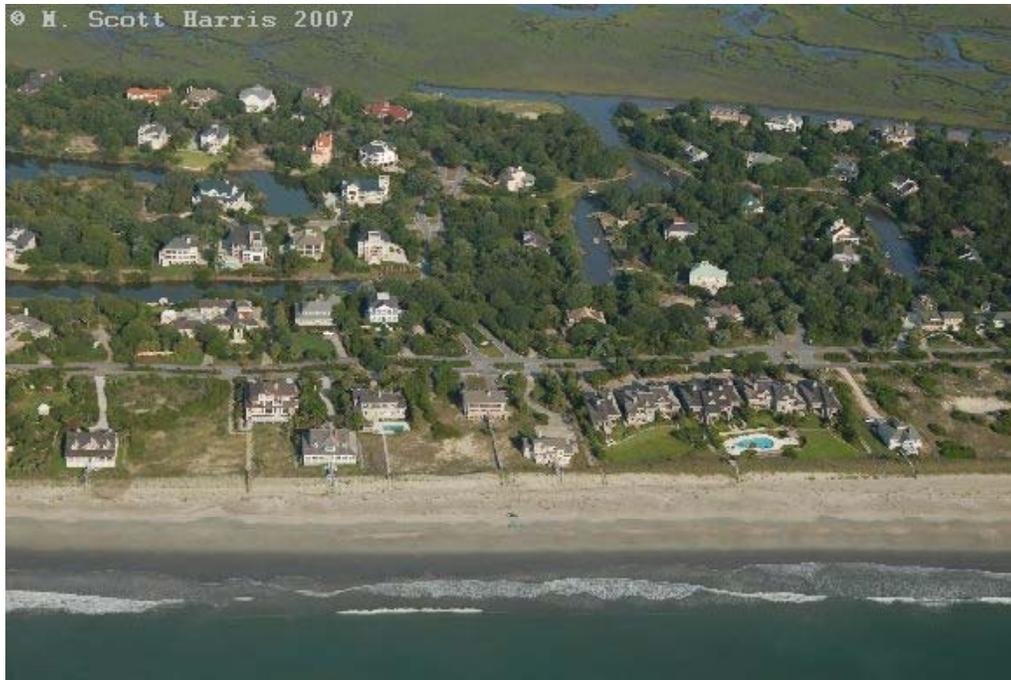
Figure 21. Aerial photograph of DeBordieu Island near station 4130.

Stations 4150-4180 are located north of the bulkhead. This is a mostly undeveloped area with an extensive dune field, and historically the beach is usually quite stable. From May 2004 through June 2005, and also through May 2006 the dune field here once again remained unchanged. Station 4150 also received renourishment sand, extending the profile 150' seaward. Station 4160 experienced some minor berm and upper beach accretion from the renourishment spillover, while 4170 experienced some accretion on the berm and lower beachface.

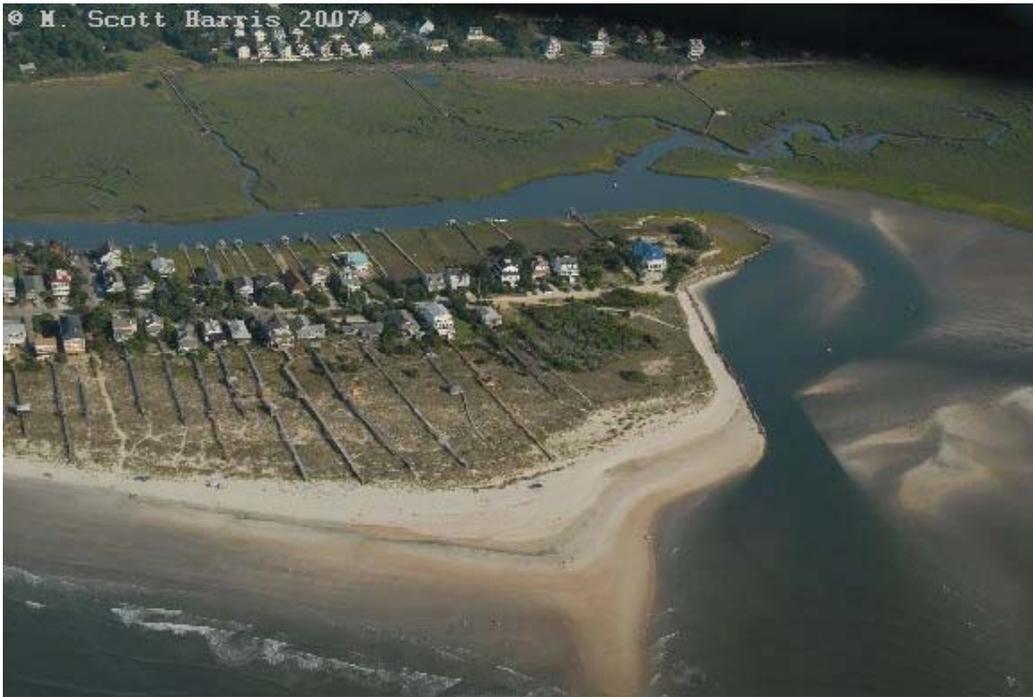
Stations 4285 to 4295 are located closest to Midway Inlet, where the beach is much wider and is generally more dynamic. The long-term trend here is accretional, and most houses are several hundred ft landward of the high-tide water line. The entire beach profile was fairly stable here in the past, with minor accretion along 4285 and 4290 and a shallowing of the profile above 0 ft at 4295 due to an inlet bar welding event (see Figure 23). Station 4285 did experience some accretion on the seaward side of the primary sand dune and erosion between 0 ft and -5 ft. Station 4290 experienced minor accretion throughout the profile down to -5 ft.

Figure 23. Northern end of Pawleys Island. A bar has migrated onto the island here (Photo Credit: Scott Harris, June 22, 2007).

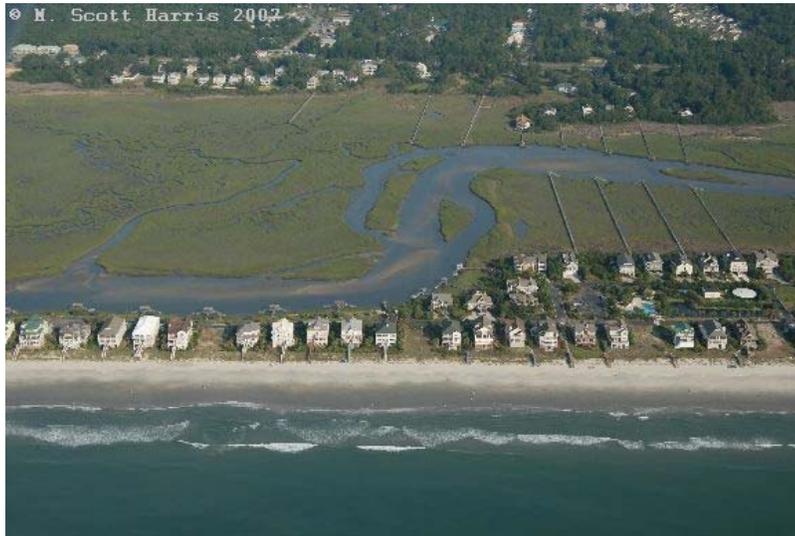
Figure 25. Aerial photograph of the south end of Litchfield Beach. (Photo Credit Scott Harris, June 22, 2007)

During the past year data collected at stations 4330 to 4390 indicate an extremely stable dune field with slight accretion in the intertidal profile and the attachment of a small sand bar. Seaward of the dune, a moderate-size berm about 35 ft in width that formed between 2003 and May 2004 was eroded away by June 2005, as the upper-beach profile returned to its 2003 shape. From 2005 to 2006, the beach between 0 ft and -5 ft eroded, while above and below these contours accretion occurred.

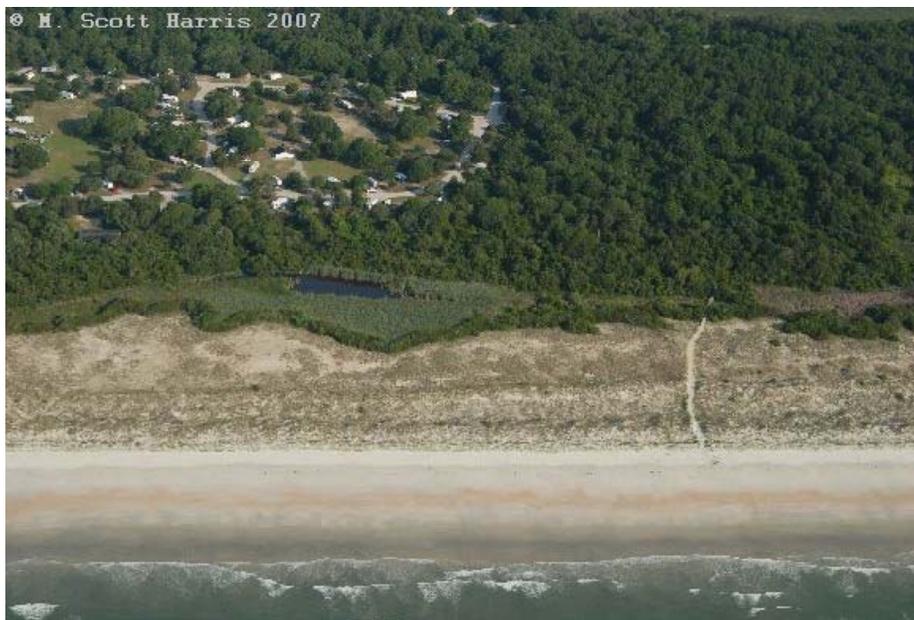
Figure 27. Aerial photograph of Huntington Beach State Park. (Photo Credit Scott Harris, June 22, 2007)

As proximity to Murrells Inlet increases the primary dune becomes somewhat smaller and the shoreline can become more dynamic, although the inlet itself is stabilized by jetties that were constructed in the early 1980's. At station 4535, a small dune formed 25 ft seaward of the 2005 position; however the profile exhibited erosion from +5 ft to 0 ft and accumulated below -1 ft. Stations 4545 similar erosion of the upper shoreface with a slight increase in elevation of the primary dune. Stations 4555 and 4565 were more dynamic, experiencing erosion from the seaward dune face down to the -5 ft contour and movement of the dune approximately 10 ft landward.

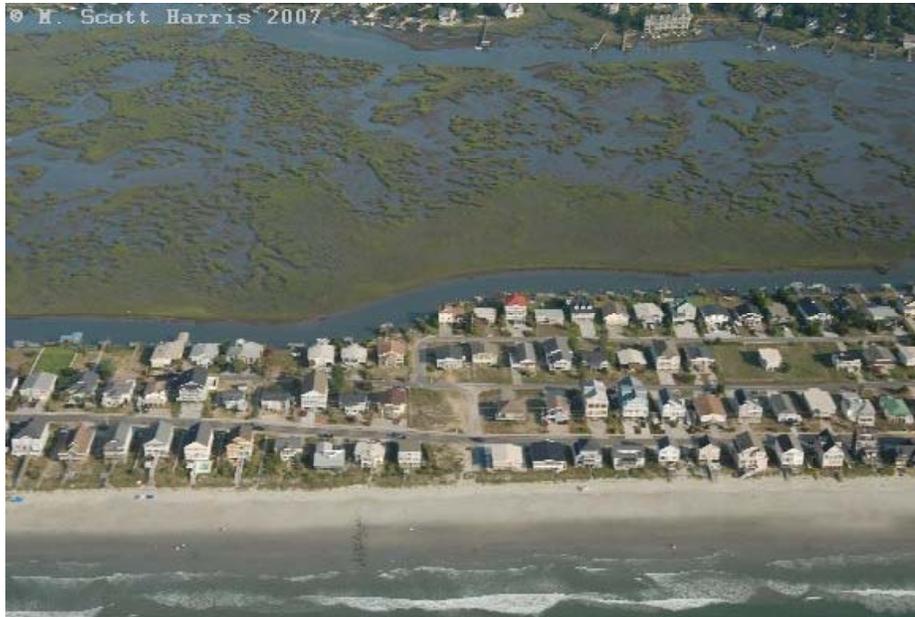
Figure 29. Aerial photograph of Garden City near Station 4970. (Photo Credit Scott Harris, June 22, 2007)

North of station 4960 the shoreline is predominantly armored and the beach width decreases. Stations 4950 through 4975 have lost the berm established between +5 and 0 ft prior to 2004. Stations 4960 through 4999, in Georgetown County, and station 5000, in Horry County just south of the pier, still show a minimal dry sand beach seaward of a small dune or bulkhead.

Stations 5005 to 5035, the northernmost section of Garden City in Horry County from the pier to Melody Lane, are mostly armored and lack a dune but have a minimal dry-sand beach. Prior to the 1998 renourishment project this area had a substantial sediment deficit, and the renourishment has not performed as well here. Between May 2004 and April 2006 stations 5005 through 5035 showed significant erosion on the upper beach between the +5 and 0 ft contours. Just north of here all stations showed a continued loss of the renourishment berm, now only 40 ft wide in places, and also erosion along the entire profile out to a depth of -10 ft.

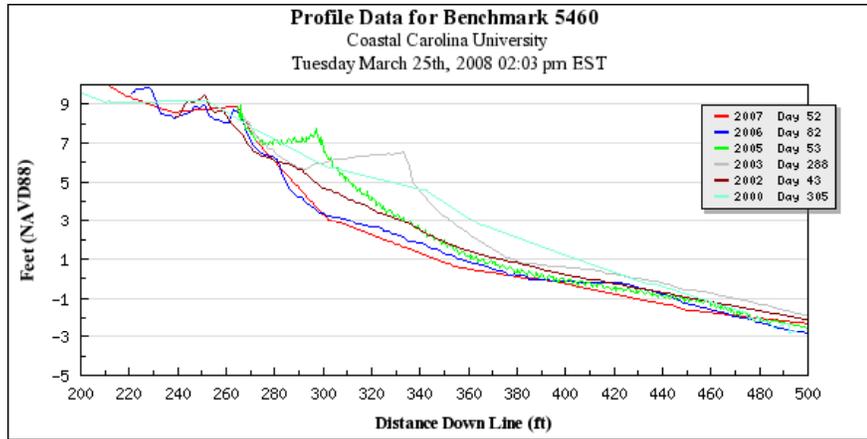
bulkheads or seawalls, and although a primary dune exists in many areas there are also unarmored sections where the highland, usually a residential lawn, simply slopes down to the berm. From February 2005 to February 2007, the stretch of coast between Station 5458 and 5468 exhibited a loss of the berm at approximately +7 ft, migrating landward between 20 and 40 ft and losing 2 to 3 ft elevation, but has now stabilized.

Figure 34. Beach profiles for station 5460.

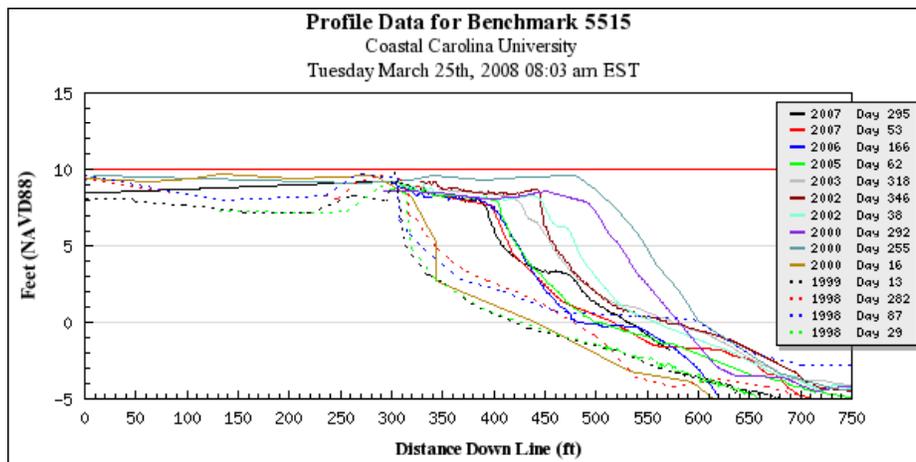
Stations 5510 to 5518 are located north of Singleton Swash along Shore Drive, where shoreline armoring is extensive and a dry-sand beach has generally been absent. This area was renourished by Horry County in 1999, when a 150-ft wide dry sand berm was created. The beach profile here has experienced post-project adjustment ever since, as the renourishment berm has cut back by 20 to 50 ft per year. From November 2003 through March 2005 the upper beach berm moved landward by another 30 to 40 ft. During the period between March 2005 and February 2007 the upper beach in this area consistently eroded between 10 and 20 ft, with a small accumulation of sand between +1 and -1 ft and erosion of the lower beach between -3 and -7 ft.

Figure 36. Beach profile data for station 5515 in unincorporated Horry County.

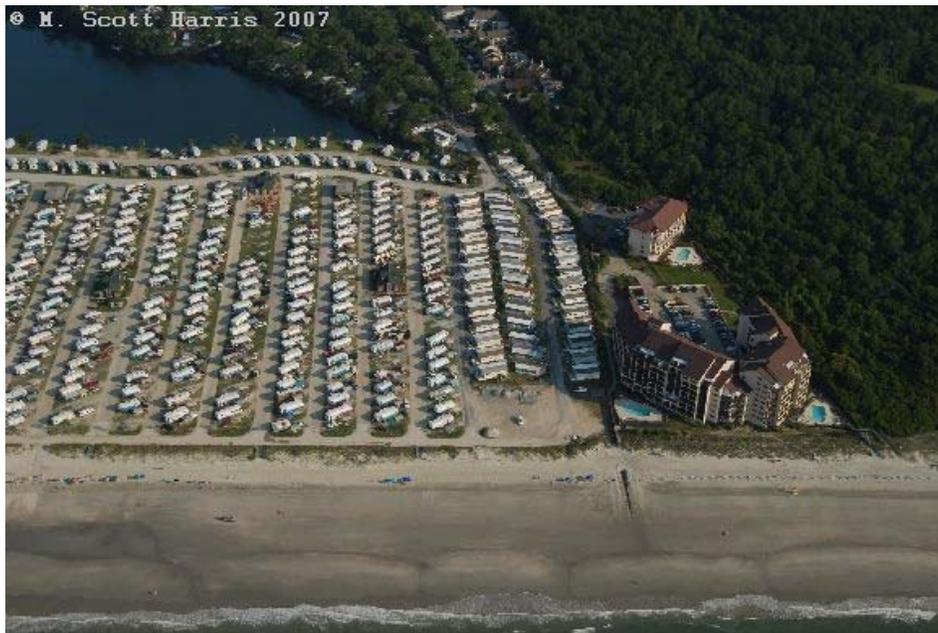
Stations 5520-5550 are located in the campground section, where oceanfront development is a mixture of campsites and resort hotels. Although this section was not renourished in 1999 it did receive some indirect benefits from the nearby Shore Drive renourishment project. Between the November 2003 and March 2005 surveys, most

stations here experienced 40 to 50 ft of berm erosion, and a general loss of sand along the entire profile from the berm down to the -3 or -4 ft contour. The beach has recovered in this section through the June 2006 survey, with 30 to 50 ft accretion of the beach between +7 and 0 ft. A trough recently formed between the -3 to -6 ft elevations along this portion of the coast.

Figure 37. Aerial photograph of campground, condominiums, and natural area near stations 5550 and 5560.

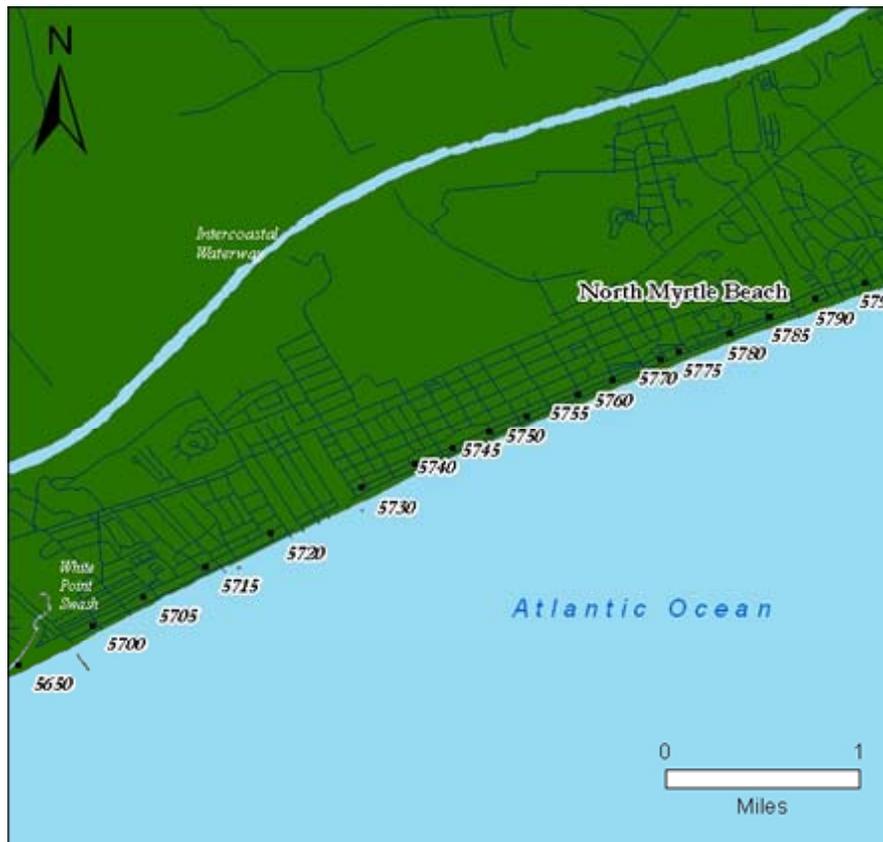
Figure 38. Location of benchmarks in the southern section of the North Myrtle Beach area.

This section includes the City of North Myrtle Beach and Atlantic Beach, from White Point Swash to Hog Inlet. The shoreline is heavily developed and much of it is armored, with alternating zones of commercial and residential structures. The beach at North Myrtle Beach is typically wider and flatter than other Grand Strand beaches. The long-term erosion rate is about a half-foot per year. North Myrtle Beach was renourished by the US Army Corps of Engineers between September 1996 and April 1997, increasing the dry-sand beach width by over 100 ft and unit-width sand volumes by over 70 cubic yards per ft. The renourishment project has since stabilized, and some of the sand still remains on the upper beach. There are 43 beach survey monuments here, which were surveyed in March 2004, January or May 2005, May 2006, and January/February 2007.

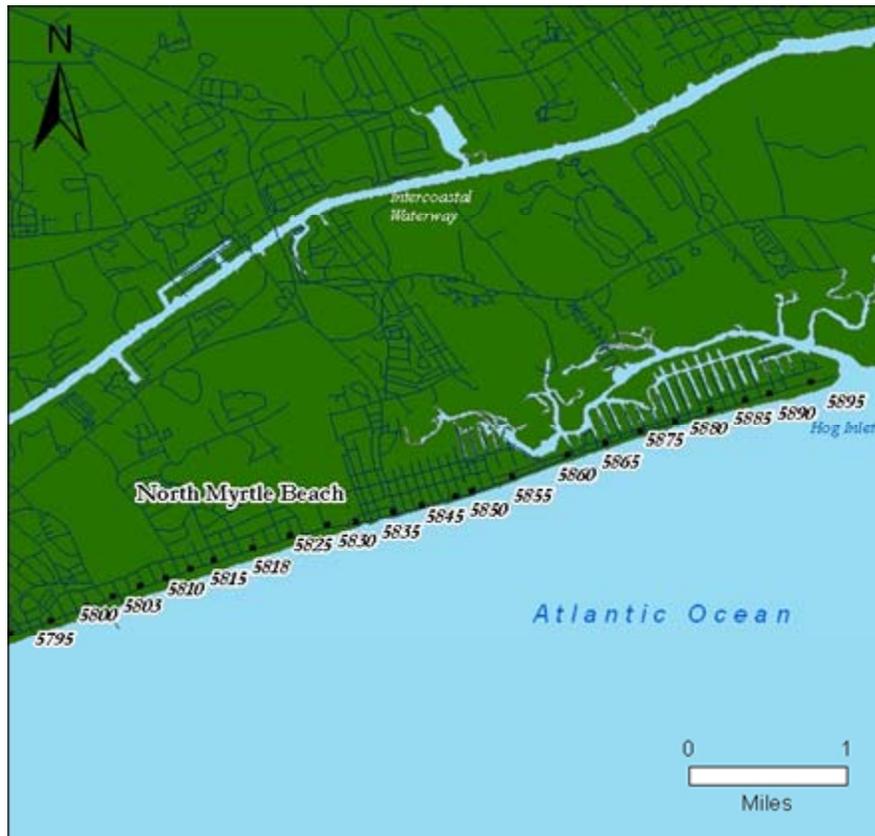
Figure 39. Benchmark locations for the northern section of North Myrtle Beach.

5798 are located, most stations experienced accretion of the profile. In the Ocean Drive section, from 2nd Ave. North to Sea Mountain Highway where stations 5800 to 5830 are located, most stations were stable to slightly erosive at the upper berm (+5 ft), with accumulation of sand between 0 and -5 ft. At many stations, the primary dune expanded seaward from just a few ft to over 15 ft.

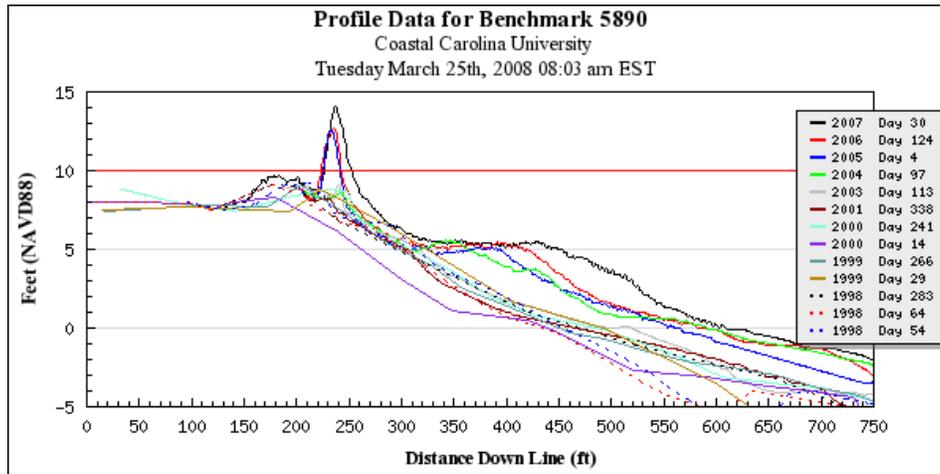
but most were stable or even accretional on the primary dune and upper beach. Station 5895 on Hog Inlet shows the formation of a new channel and migration of the berm landward 45 ft. Stations near the inlet, particularly 5885 and 5890, indicate the welding of a large bar and extension of the +5ft contour 20 to 50 seaward.

Figure 40. Beach profile data for Station 5890 in North Myrtle Beach.

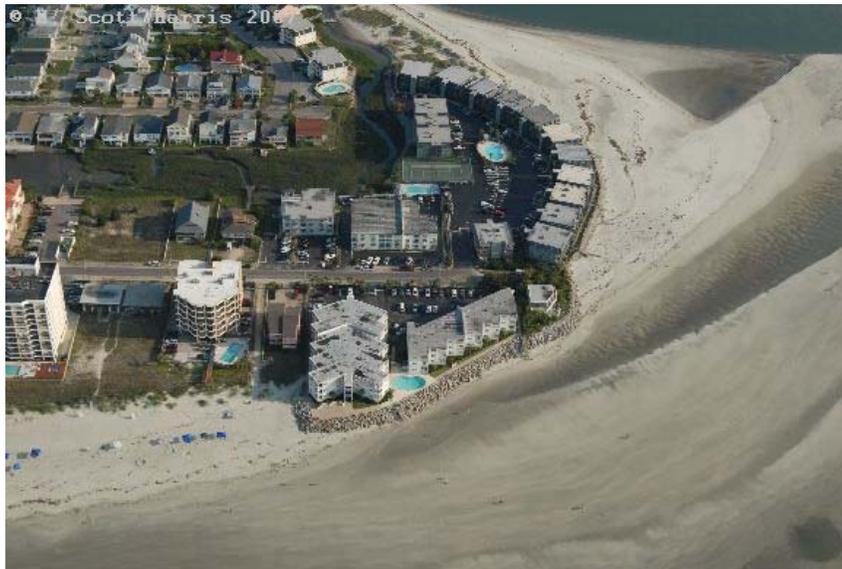
Figure 41. The north end of Cherry Grove, where inlet processes make this region very dynamic. A new sand bar welds on to the shoreface here.

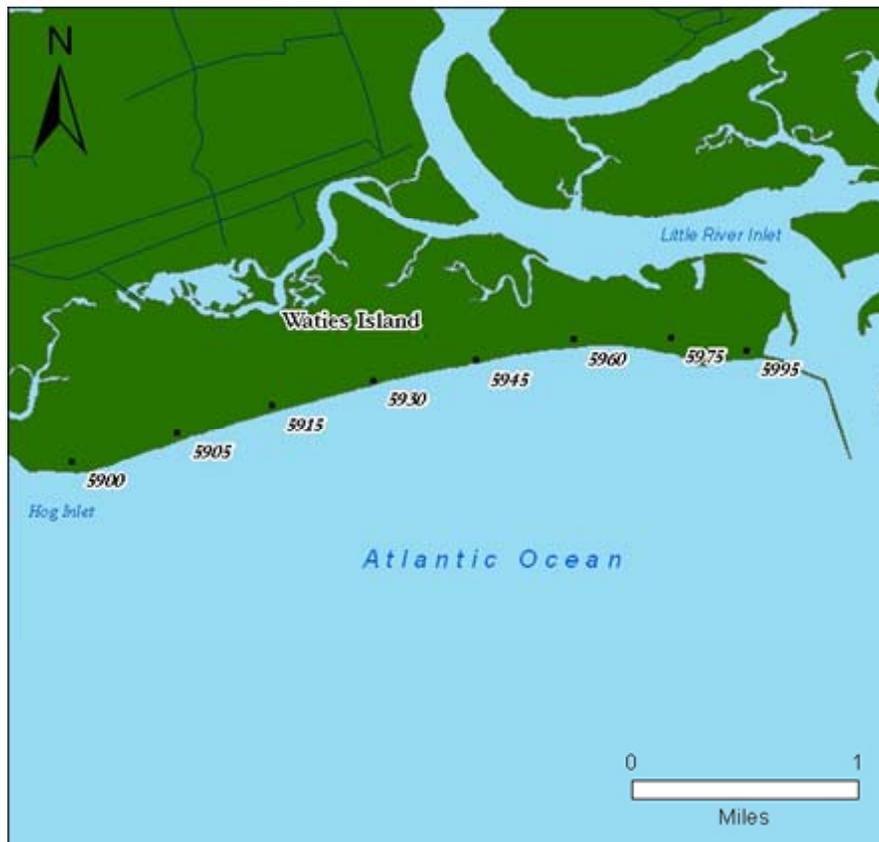
Figure 42. Benchmark locations for Waties Island.

Waties Island (listed here with a spelling change from the previously used “Waites” for historical and geographical name accuracy) is an undeveloped three-mile long barrier island located between Hog Inlet to the southwest and Little River Inlet to the northeast. Little River Inlet was stabilized by the construction of a jetty system between 1981 and 1983. The southwest end of Waties Island is an unstabilized inlet zone, the central portion is a standard zone, and the northeastern section is a stabilized inlet zone. Most of the island has a long-term erosion rate ranging from -4 to -10 ft per year, although jetty construction has helped to stabilize the shoreline and lessen the erosion. During most of the 1990’s the Hog Inlet shoreline was extremely erosional, losing several hundred ft, but has changed to an accretional mode in recent years. There are 6 monitoring stations on Waites Island, which were most recently surveyed in May 2004, January 2005, December 2005, and May 2007.
